Seismic Resistance and Retrofitting of Unreinforced Masonry Buildings

Seizmička nosivost i ojačanje konstrukcija zgrada od nearmirane zidarije

Dr. Svetlana Brzev, P.Eng.

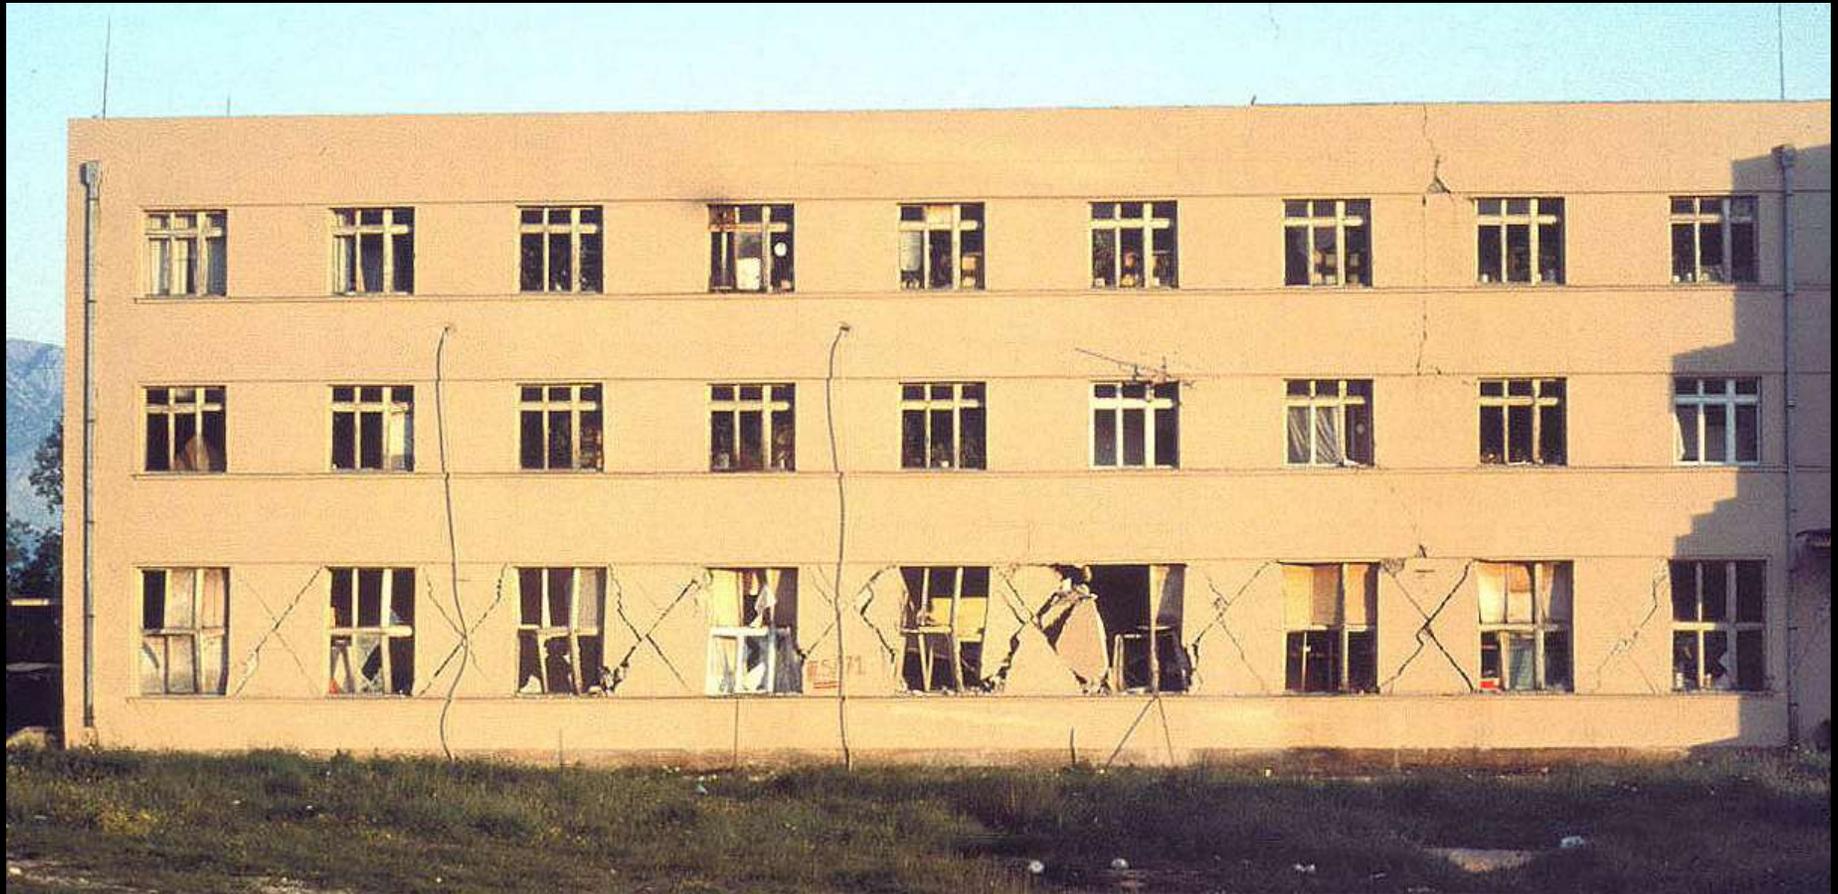
Diagonal tension shear failure: evidence from past earthquakes

1979 Budva, Montenegro eq. (M7.0)

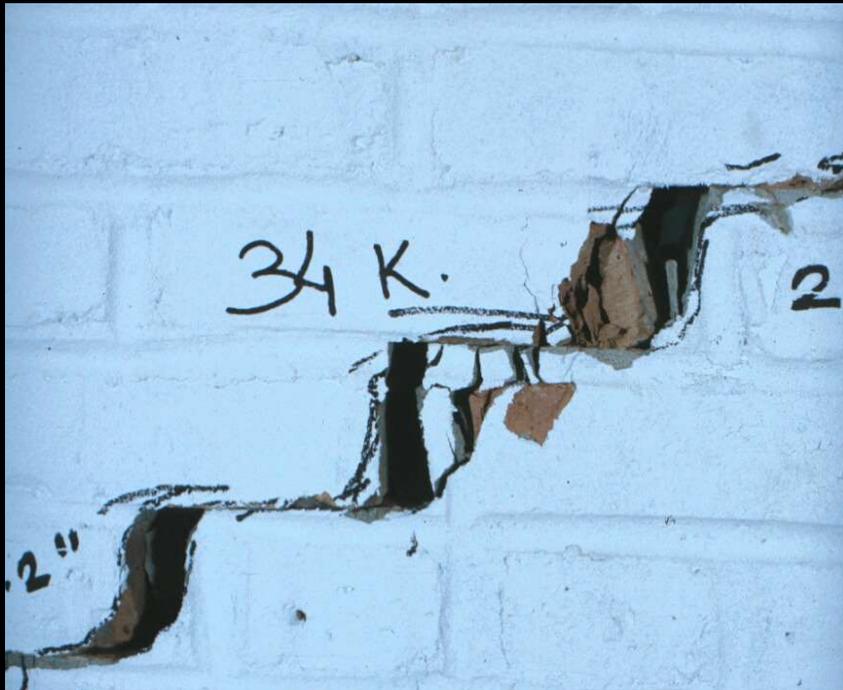
- Stair-stepped cracks - pass through vertical and horizontal mortar joints
- Also known as bed joint sliding failure (USA and Canada)

Stair-stepped joint shear failure

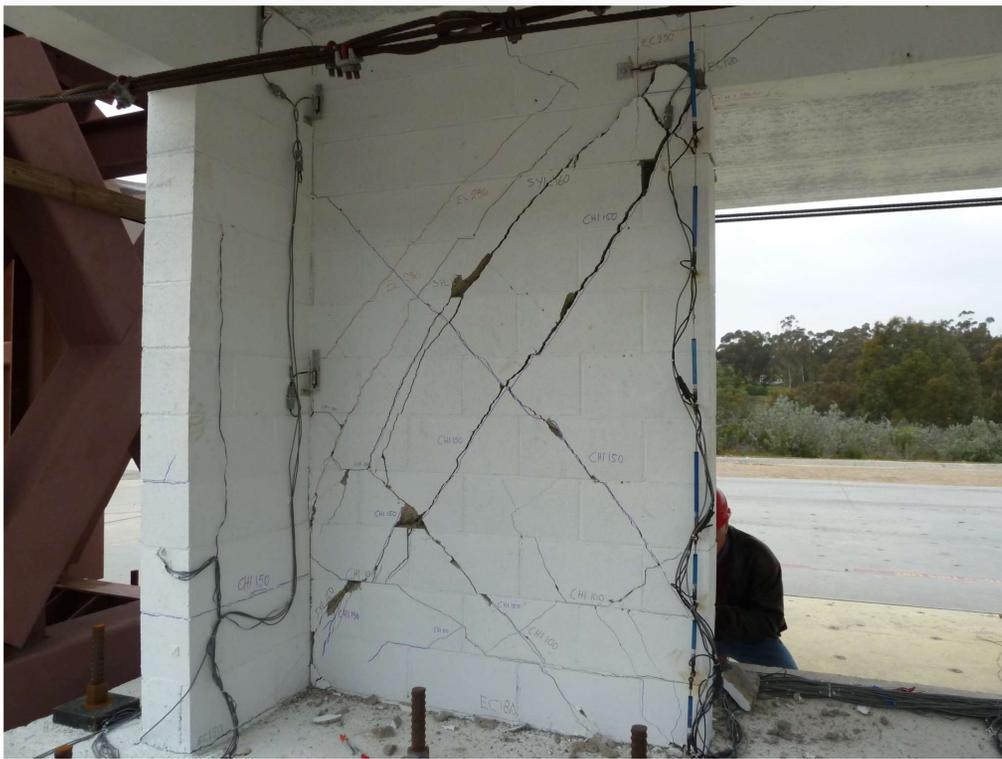
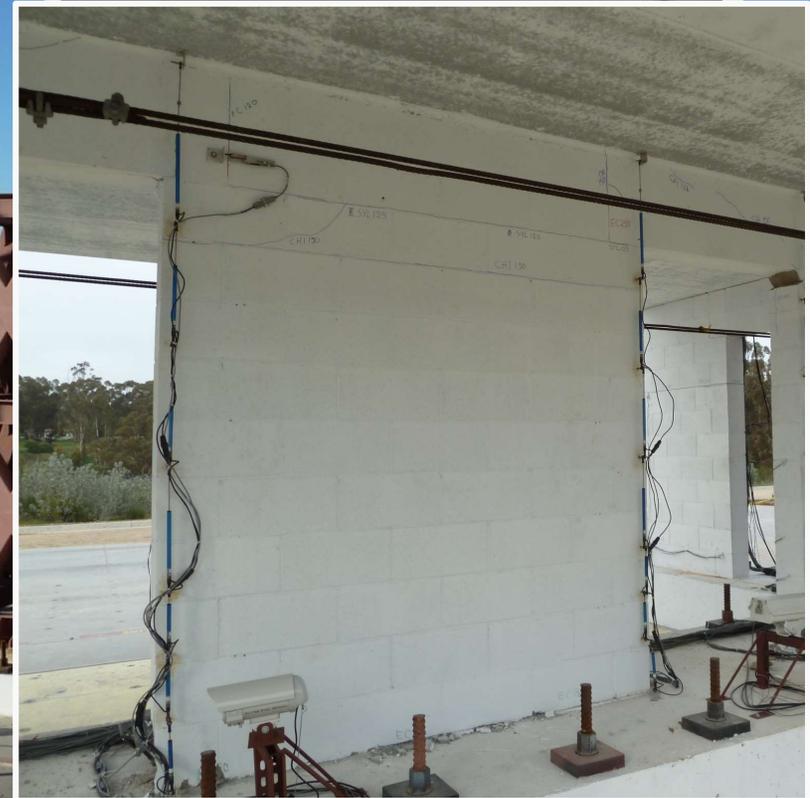
Sliding shear failure

Shaking table testing of a reinforced masonry building by Stavridis, Klingner, Shing, Ahmadi (University of California San Diego, 2011)

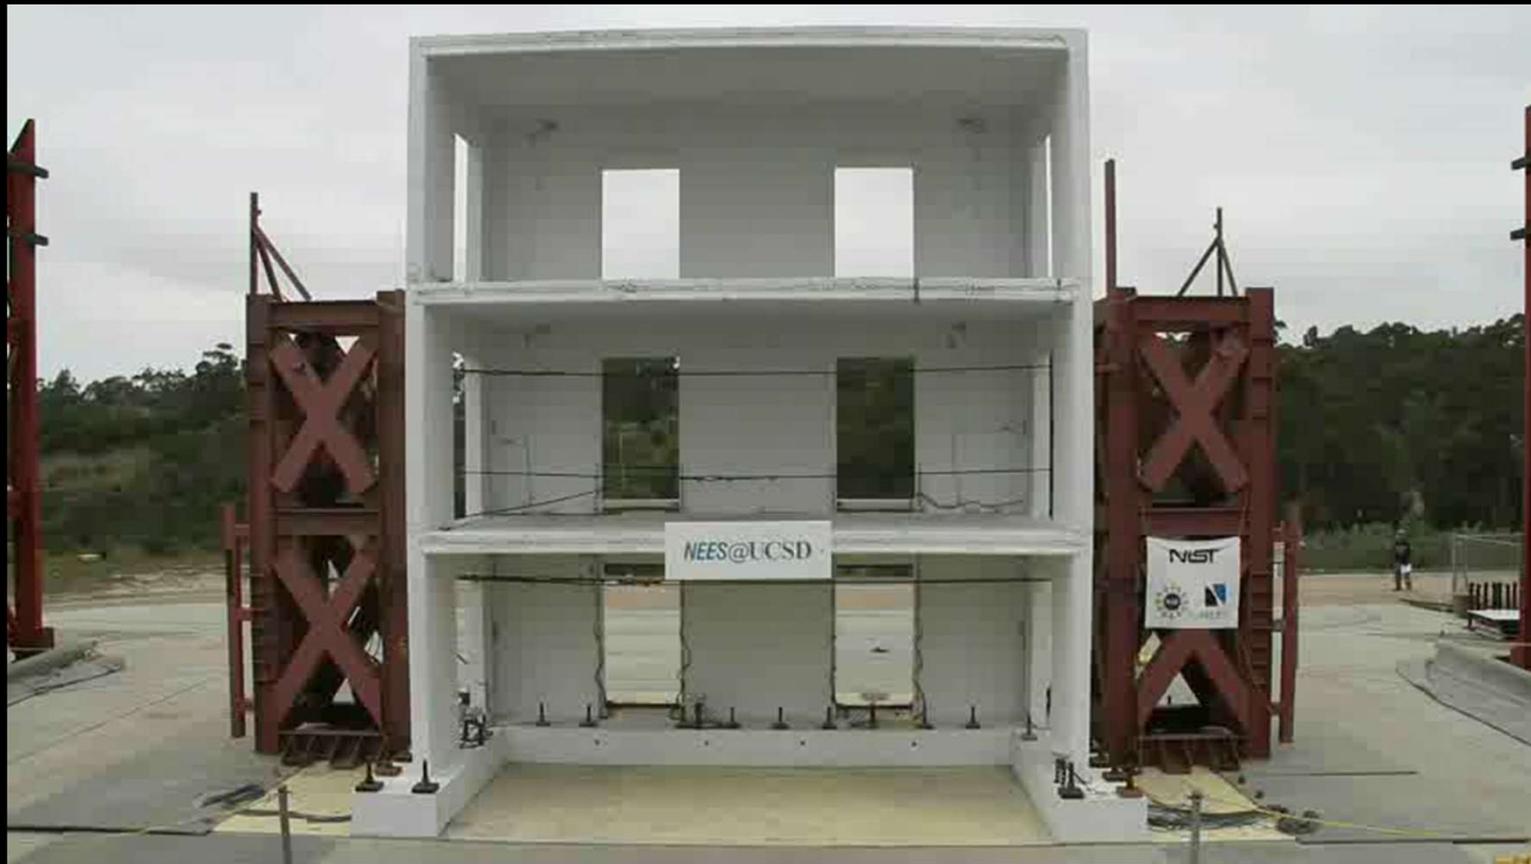
Shaking Table Testing at the University of California San Diego, USA

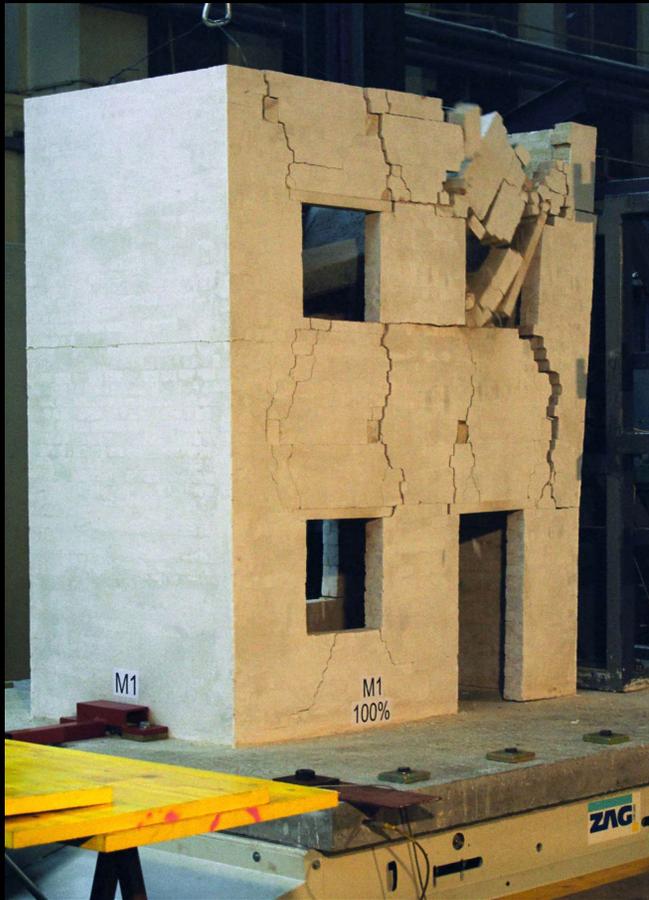
Alternative tie solution: composite (CFRP) ties

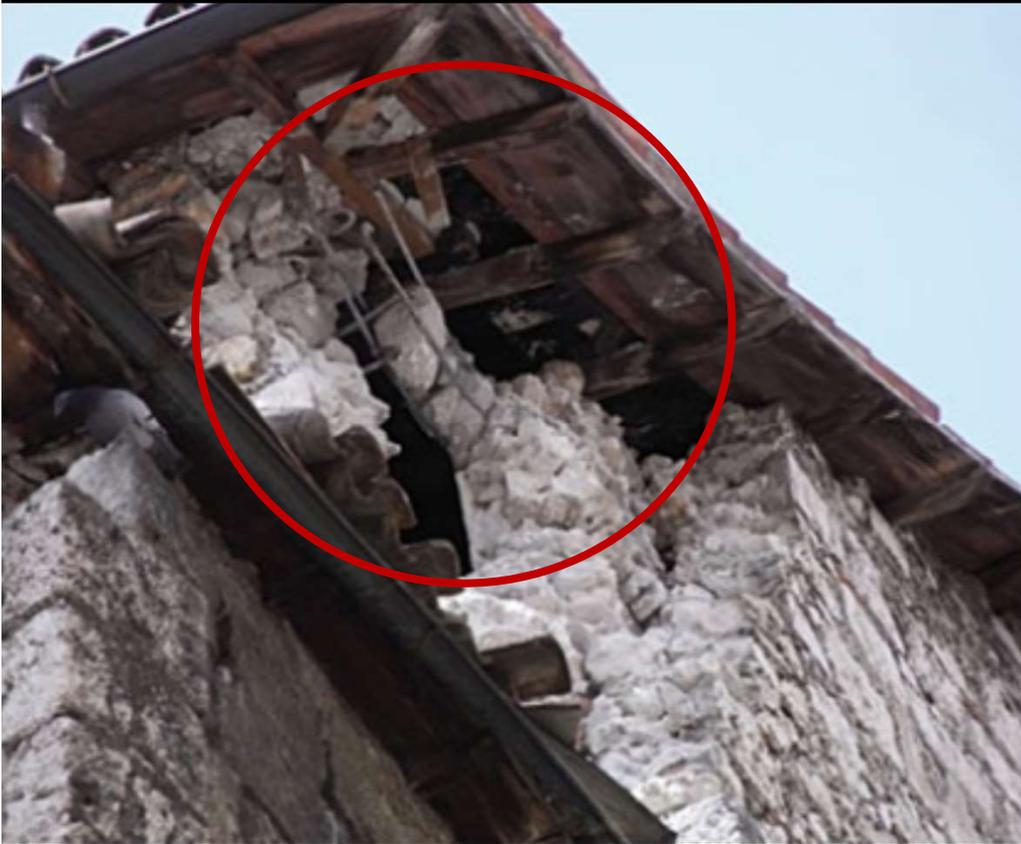
- Evidence of failure of RC ring beams installed to retrofit heritage stone buildings in Italy
- Example: church of Santa Giusta in L'Aquila
(D'Ayala, 2014)

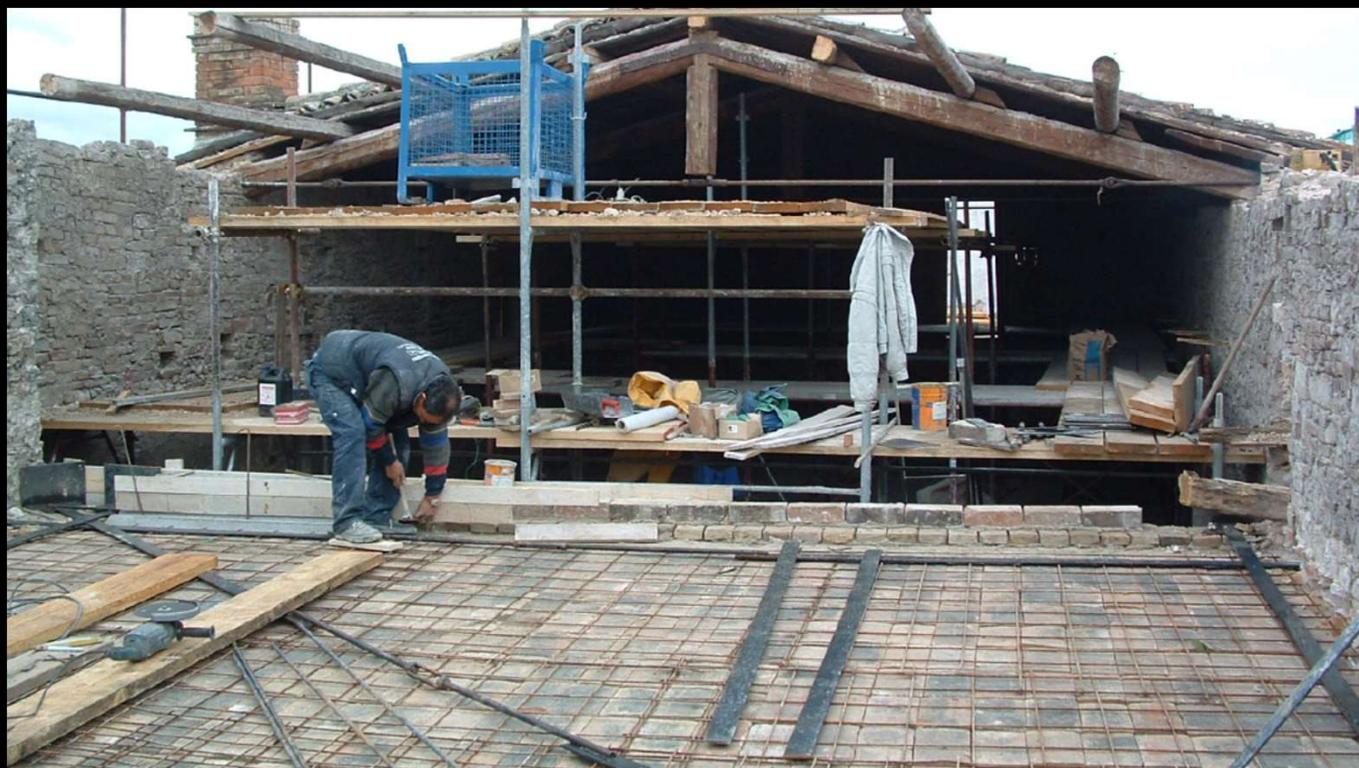
Strengthening of the Existing Timber Floors: Retrofitting example after the 2002 Molise, Italy eq.

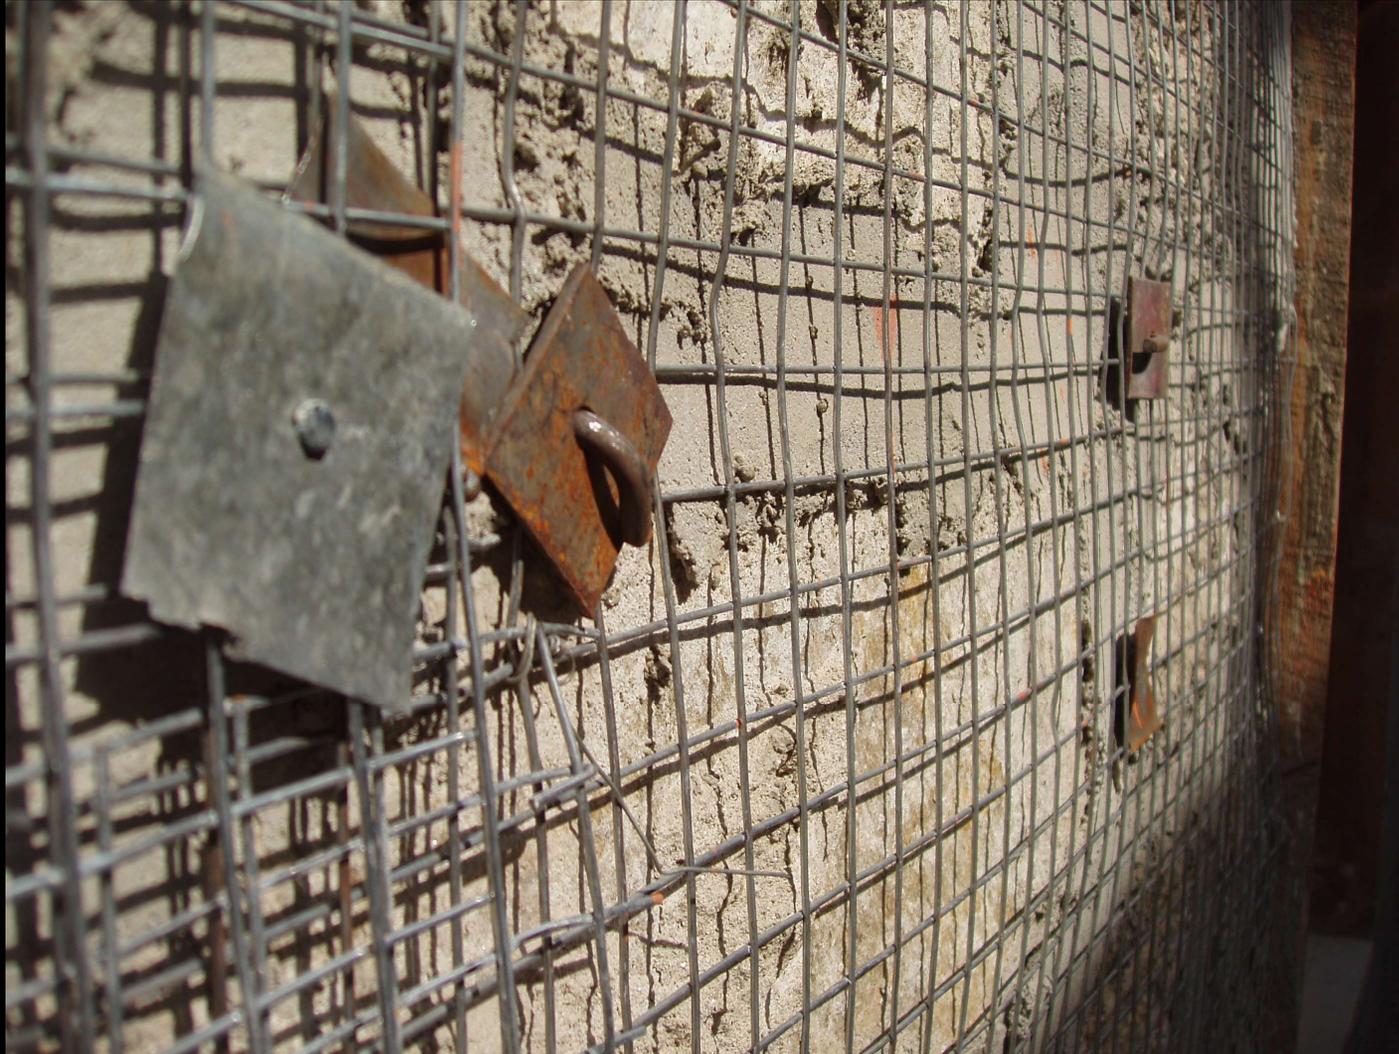
Intallation of Wall Anchors: A Potential Challenge

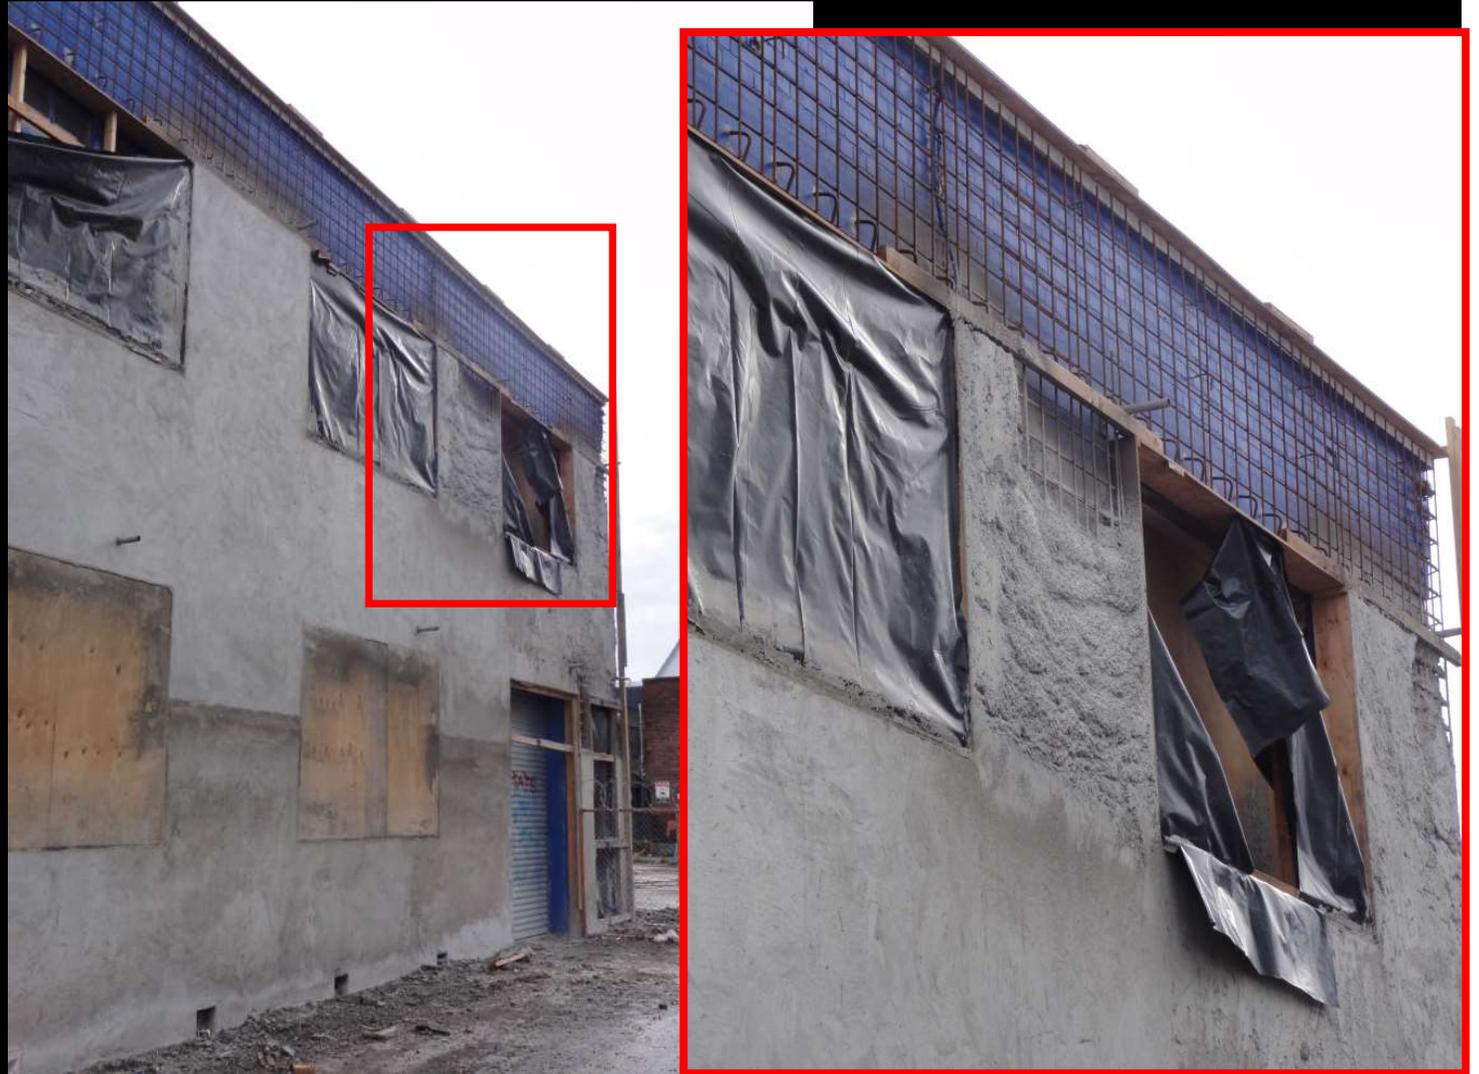
Shotcrete – good performance in the 2011 Christchurch Eq. (New Zealand)

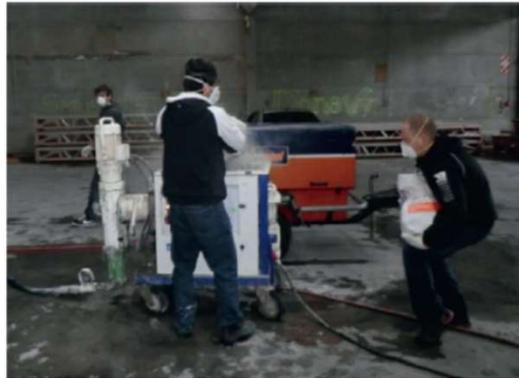
Engineered Cementitious Composite (ECC) shotcrete (Lin et al., 2014)
University of Auckland, New Zealand

(a) Adding prebagged ECC into mixer

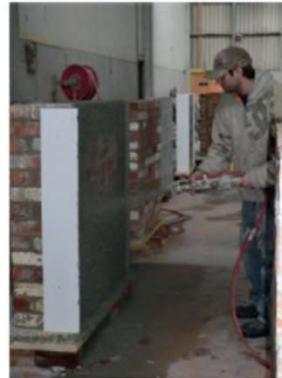
(b) Spraying of ECC shotcrete onto walette

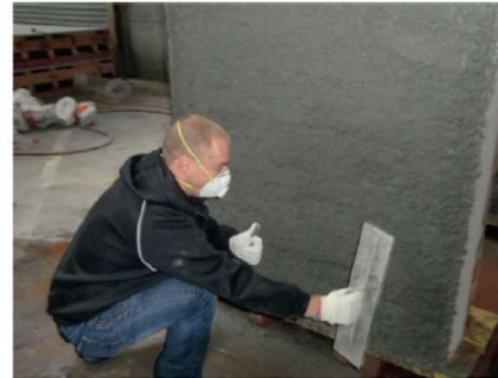
(c) Trowelling sprayed ECC flat prior to the spraying of successive layers

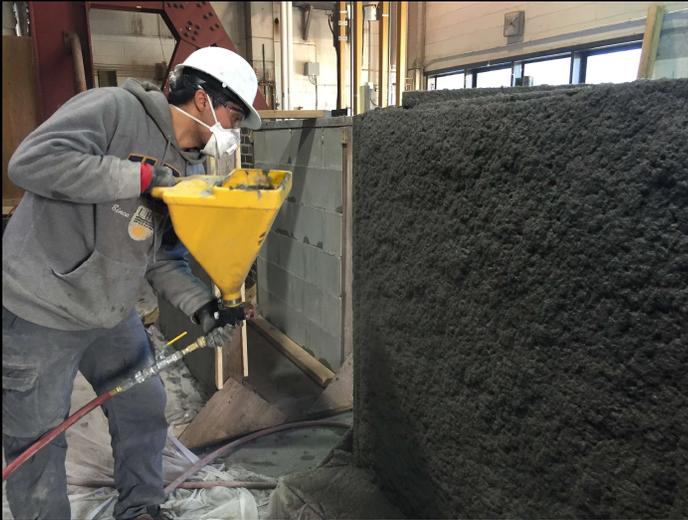
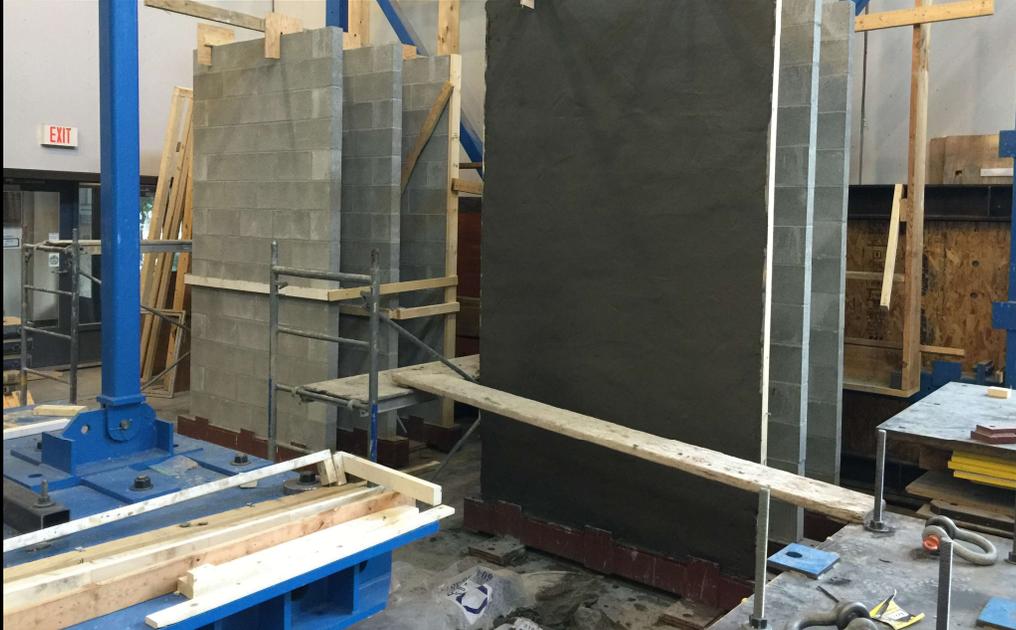
Thin overlay of sprayed fiber-reinforced concrete

EDCC combines cement with polymer-based fibres, flyash and other industrial additives

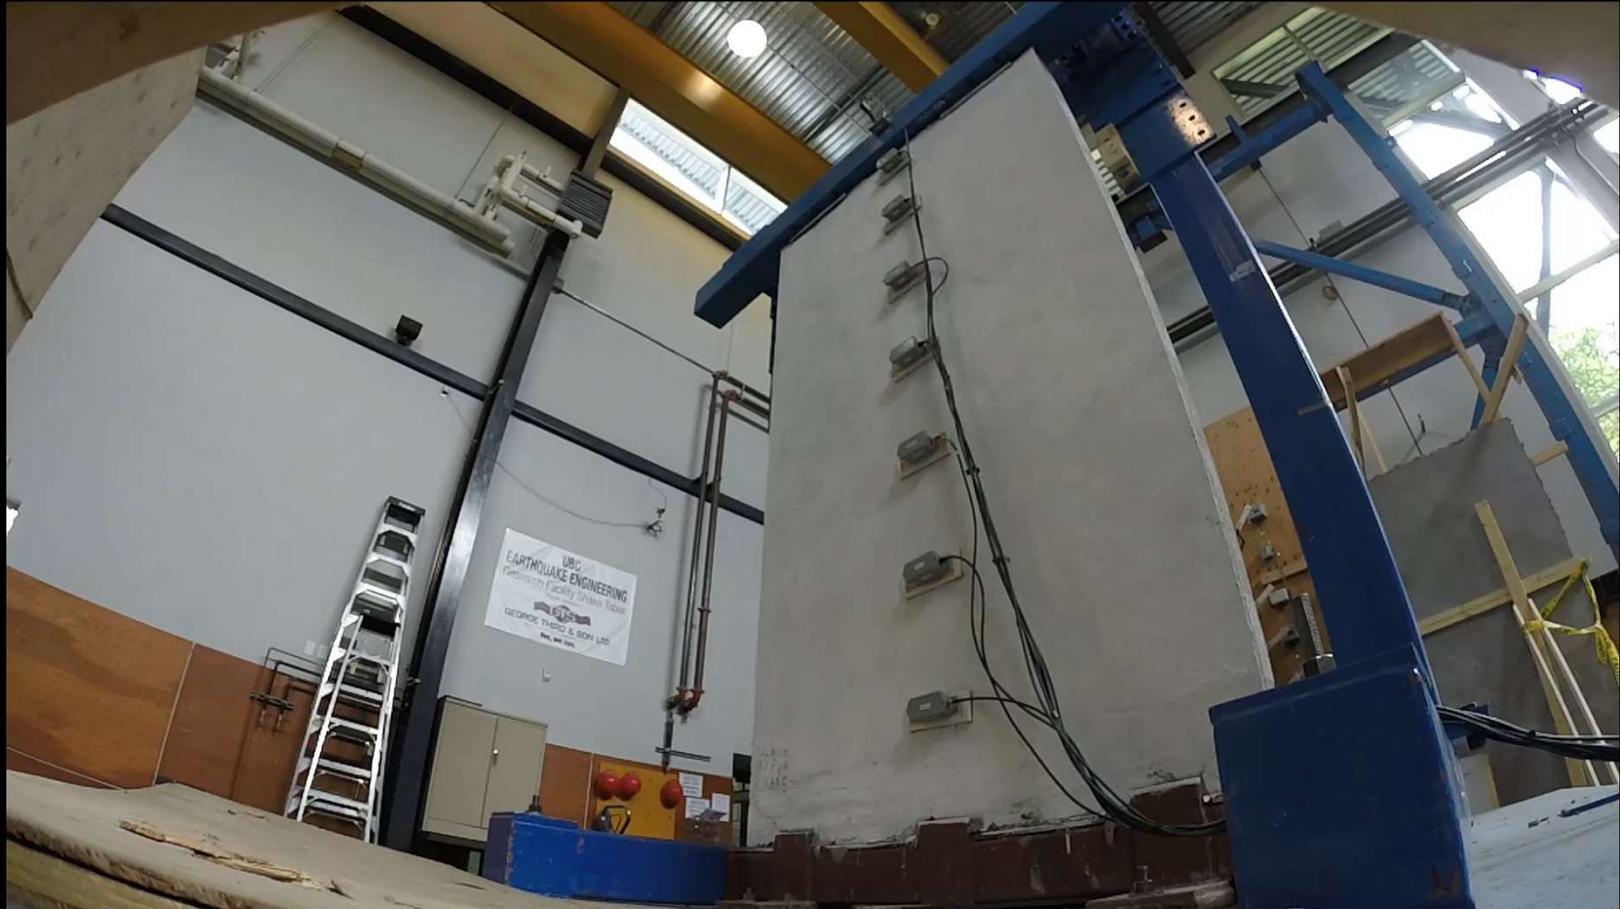
Shaking Table Testing of Masonry Walls Retrofitted with EDCC Technology (UBC, Vancouver, Canada)

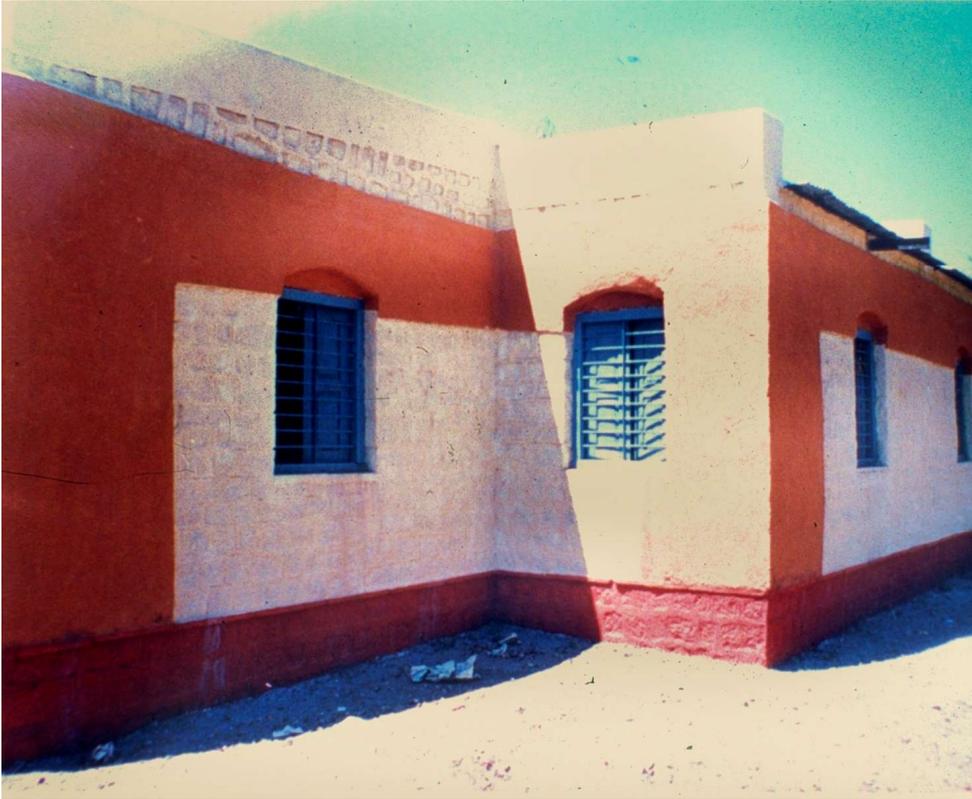
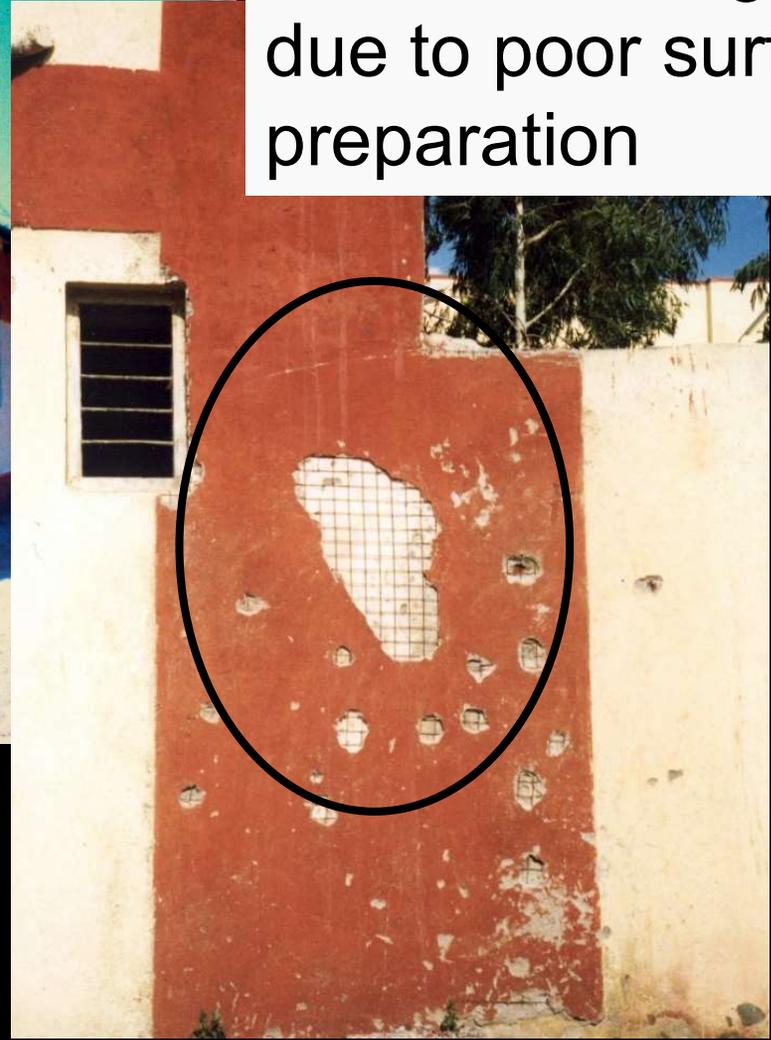
Peeling of the surface coating due to poor surface preparation
